BLIGHT IN THE CENTRAL CITY

EAST ST. LOUIS, ILLINOIS

By Hubert O. Williams

October 19, 1967

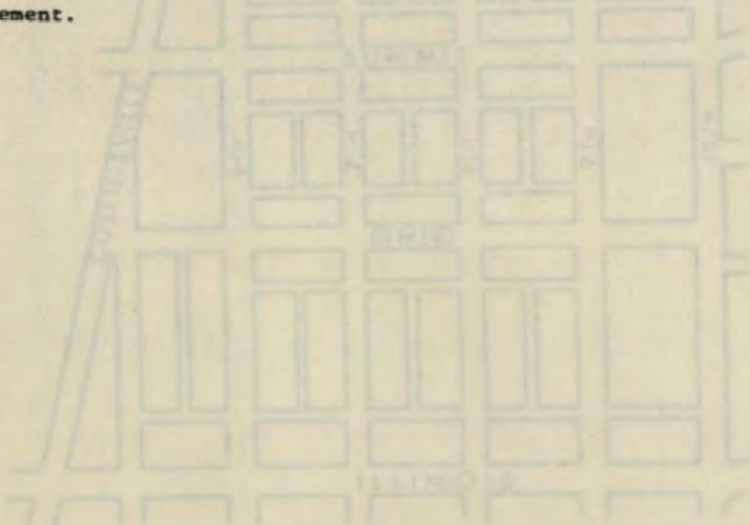
Area 5

Area Five is bounded by Illinois Avenue, Collinsville Avenue, St. Clair Avenue and Tenth Street. Nearly one-third of the homes in this area are so deteriorated that demolition is necessary. Some of the very poor homes are scattered among sound and low-repair cost homes. In these blocks rehabilitation efforts should be taken to improve the repairable property and spot demolition undertaken to eliminate the non-repairable structures. In parts of Area Five, total redevelopment is necessary to combat blight. Most noticeable is Sixth Street where the majority of homes are so deteriorated that demolition is the only remedy. Within Area Five is a well-maintained public housing project which serves as a basis for neighborhood improvement.

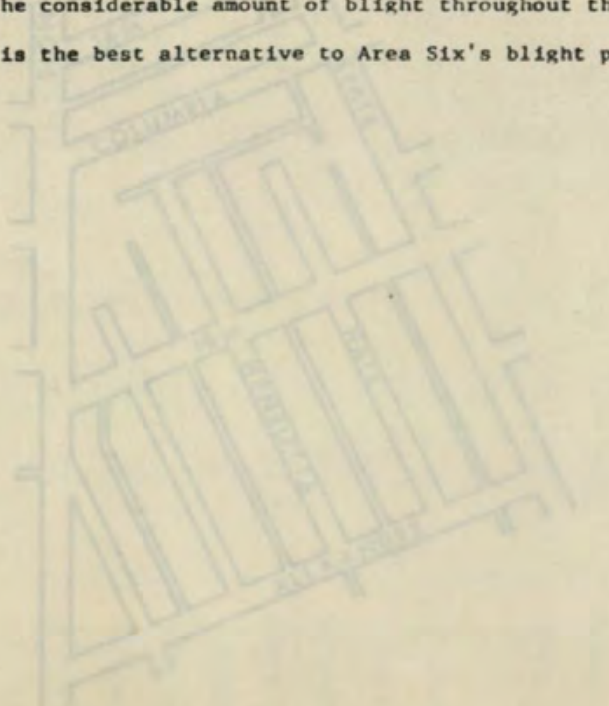
Area 6

Area Six lies west of Alexander Avenue between State Street and Illinois Avenue which form a triangle near Tenth Street. The western section of the neighborhood, adjacent to the Sears shopping complex and the Central Business District, is principally commercial in nature. Nearly one-third of the residences in this area are in need of demolition. Most of these homes are on Henrietta, Hall and Columbia Avenues. The cost to repair them is prohibitive. Another third of the homes are sound, but the remainder are deteriorating at a high repair-cost level. With the encroachment of commercial activities at the western end of Area Six and the considerable amount of blight throughout the area, redevelopment is the best alternative to Area Six's blight problems.
